**NATIONAL TRANSPORTATION SAFETY BOARD
WASHINGTON, D.C.**

FIRE AND EXPLOSION GROUPS FACTUAL REPORT

**Appendix III
(Tests and Study)
(81 pages)**

TWA FLIGHT 800 ACCIDENT INVESTIGATION

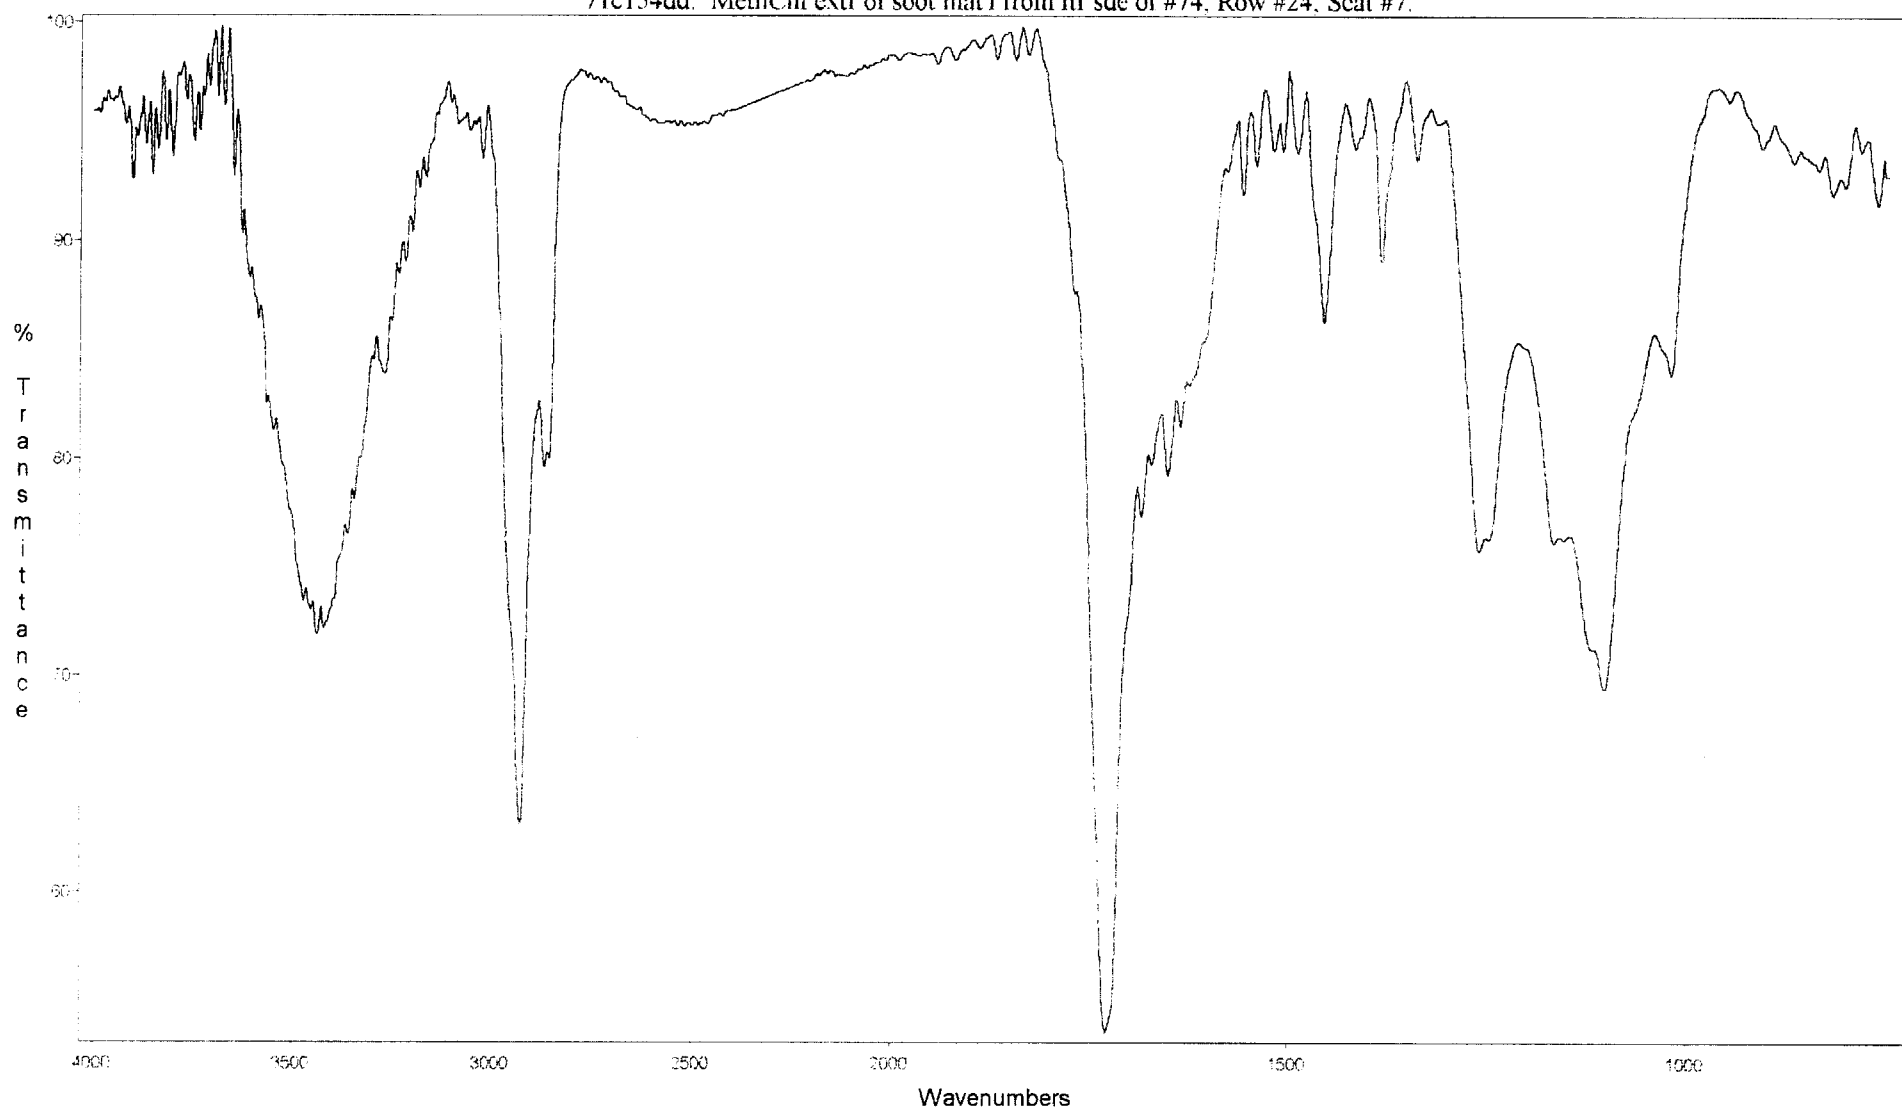
- 3.5 Sample #74, Row 24, Seat 7 (Figure 17) appeared to be a metal alloy (probably aluminum) and was characterized by charred material on both sides. Material from each side was removed and FTIR spectra generated. For the purposes of this discussion, the terms "darker side" and "lighter side" will be used to differentiate between the two sides. A gold colored glazed and a black organic appearing material were removed from the darker side and spectra generated. The FTIR spectra for each is provided in Figure 18 and Figure 19 respectively. From the lighter side, a "soot" looking material was extracted with an organic solvent and a spectrum generated. The spectrum is provided in Figure 20.

Figure 20. Extraction of "sooty" material from lighter side of sample #74.
